Sample Fracture Critical Member Locations and Condition for Trusses

County: Adair FHWA No.: 012345 County ID: Prescott 13 Insp. Date: 7/18/2013

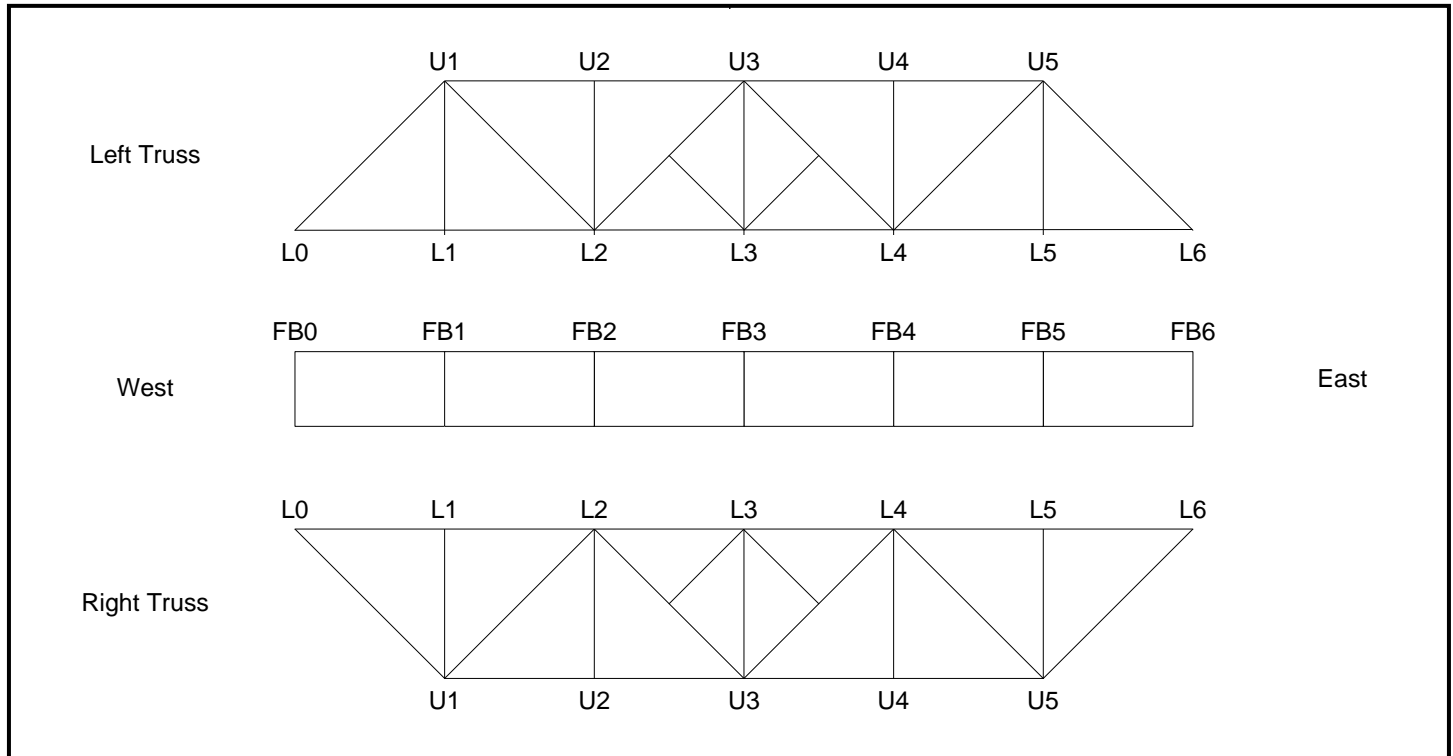
Span	Member Location	FC Member?	Comment #'s Left Truss	Comment #'s Right Truss	Inspection Procedure Required	Inspection Procedure Used
1	L0-U1		2	2		
1	L0-L1	Y	1	1	Hands-on	Hands-on
1	U1-L1	Y	1, 8	1, 8, 5	Hands-on	Hands-on
1	U1-U2		2	2		
1	U1-L2	Y	1, 4	1, 4	Hands-on	Hands-on
1	L1-L2	Y	2	6	Hands-on	Mag-Partical
1	U2-L2	Y	2, 8	2, 8	Hands-on	Hands-on
1	U2-U3		2, 7	2, 7		
1	L2-U3		1	1, 4		
1	Brace at L2-U3		2	2		
1	L2-L3	Y	1, 5	1, 9	Hands-on	Dye Penetrant
1	U3-L3	Y	2, 8	2, 8	Hands-on	Hands-on
1	U3-U4		2, 7	1		
1	U3-L4		1, 4	1, 4		
1	Brace at U3-L4		2	2		
1	L3-L4	Y	2, 5	1, 9	Hands-on	Ultrasonic
1	U4-L4	Y	2, 3, 6	2, 8	Hands-on	Hands-on
1	U4-U5		2	2		
1	L4-U5	Y	1, 4	1	Hands-on	Hands-on
1	L4-L5	Y	2	2	Hands-on	Hands-on
1	U5-L5	Y	1, 3	2, 8	Hands-on	Hands-on
1	U5-L6		2	2		
1	L5-L6	Y	1	2	Hands-on	Hands-on

Code	Comment
1	No notable deficiencies.
2	Light damage.
3	Moderate damage.
4	Gusset plates damaged when torch was used to cut rivets when truss was moved.
5	Splice plates on top & bottom flanges not bolted at L3.
Code	Comment

6	Weld between the vertical & railing spacer bar cracked.
7	Channels damaged when torch was used to cut rivets when truss was moved.
8	Spacer blocks welded to vertical, welds across direction of the stress.
9	Interior splice plate top channel flange missing at L3.
